HOME INSPECTION REPORT

Inspection Fee: [Redacted]  
Yr constructed: 2002  
Age of roof: 6 yrs

Buyer's Real Estate Agent/Company: [Redacted]  
Seller's Real Estate Agent/Company: [Redacted]  
Albion Inspection Service Inspector: [Redacted]

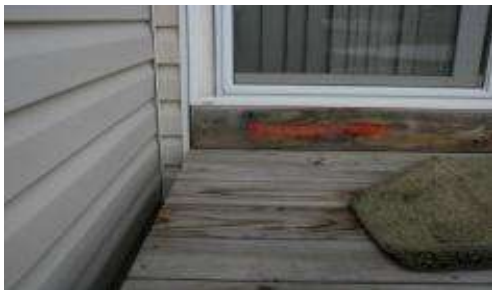
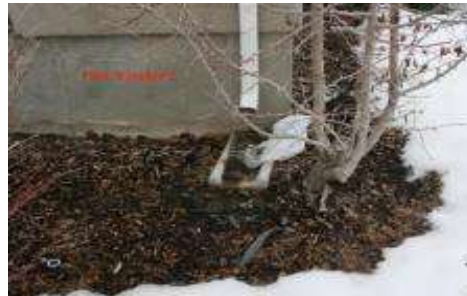
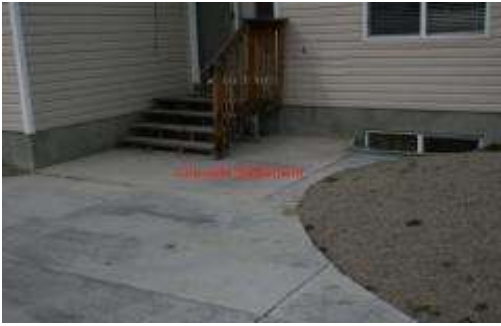
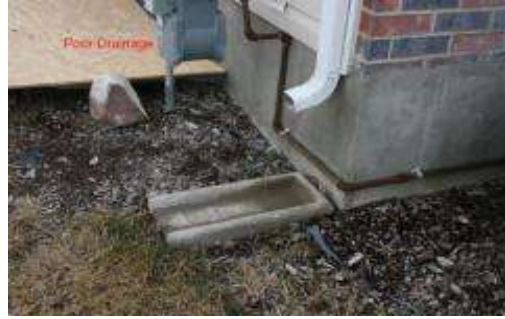
**Relevant Photos**

**Comments:** Minor Spalling & evidence of uplifting where the sidewalk section meet the driveway

<b>Condition:</b>		Satisfactory <input type="checkbox"/>	Not Satisfactory <input checked="" type="checkbox"/>	<b>Key</b>	
					*
<b>Comments:</b>	<b>Observations:</b>		<b>Yes</b>	<b>No</b>	<b>Not Inspected</b>
	Ground slope toward the home foundation?		<input checked="" type="checkbox"/>	<input type="checkbox"/>	<input type="checkbox"/>
	Are there low areas where water could pool?		<input checked="" type="checkbox"/>	<input type="checkbox"/>	<input type="checkbox"/>
	Does roof-runoff pool near the home foundation?		<input checked="" type="checkbox"/>	<input type="checkbox"/>	<input type="checkbox"/>
The east face of the home is poorly graded. Settlement of back fill has caused negative slope.

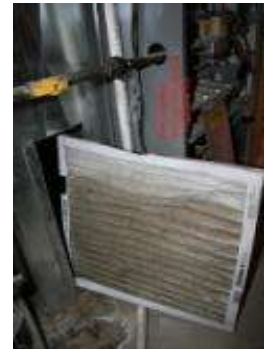
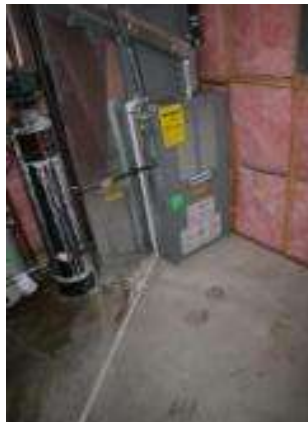
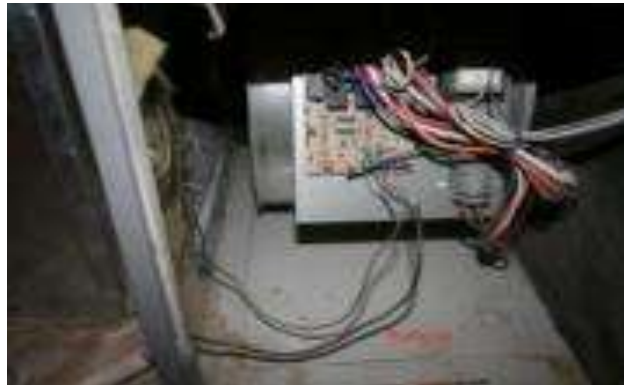
Relevant Photos

- 99  
Requires annual service, There is a lot of buildup due to an improper sized filter, and non annual maintenance.
- 102  
Ductwork is present Family room. Family room is dependant on supplemental heat from gas/fireplace/stove.

- 106  
Strongly recommend service from a qualified technician for the furnace
